Cable Corrosion Fix

THE AN/PSC-11 SINGLE CHANNEL, ANTI-JAM, MAN-PORTABLE (SCAMP) RADIO SET HAS A CABLE CORROSION PROBLEM.

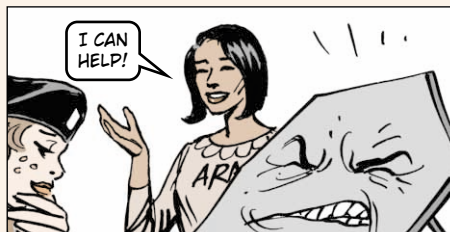
"IF YOUR SCAMP CABLES HAVE A **YELLOW BAND** ON THEM, THEY HAVE ALREADY BEEN REPLACED AND ARE GOOD TO GO."

"IF THEY **DON'T** HAVE THE YELLOW BAND, REPLACE THEM BY CALLING ROCKWELL COLLINS AT THEIR TOLL-FREE WARRANTY HOTLINE, (800) 797-8429, AND REQUESTING A DIRECT EXCHANGE. THEN FOLLOW ROCKWELL'S INSTRUCTIONS."
